Manhole Inspection Summary

Manhole # S45I__012MH

Insp Date: **4/24/08 8:47 AM**

Location Address: **424 portugal st** Cross Street: **s wasington st**

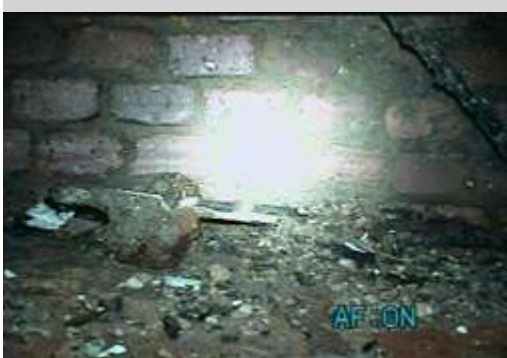
MISC

bench debris

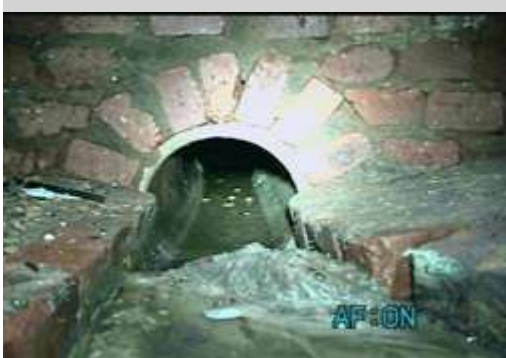
MISC

channel debris

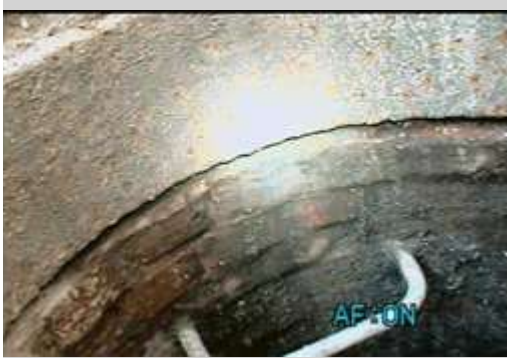
Defect 2

Chimney / Frame Adjustment ☒ Exists Material: **Brick** ☐ Parged Height: **1** (in.)

Condition: ☐ Sound ☐ Cracked ☐ Root Intrusion ☐ Loose Brick ☒ **Deteriorated**

deteriorated chimney frame adjustment

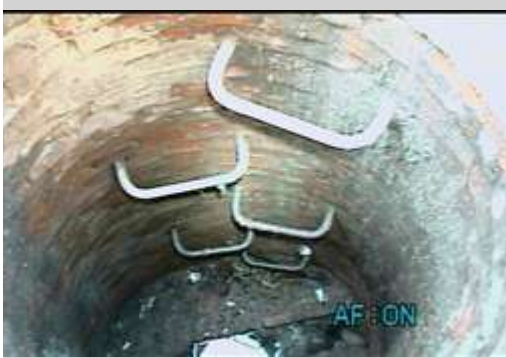
Defect 1

Steps Count: **5** Missing: **0** ☒ **Corroded**

corroded stairs
